SOLID WASTE MANAGEMENT UNIT (SWMU) EVALUATION
FOR
U.S. ARMY GARRISON FORT BELVOIR, VIRGINIA
INDIVIDUAL VPDES INDUSTRIAL STORMWATER MAJOR
PERMIT NO. VA0092771

JUNE 2019

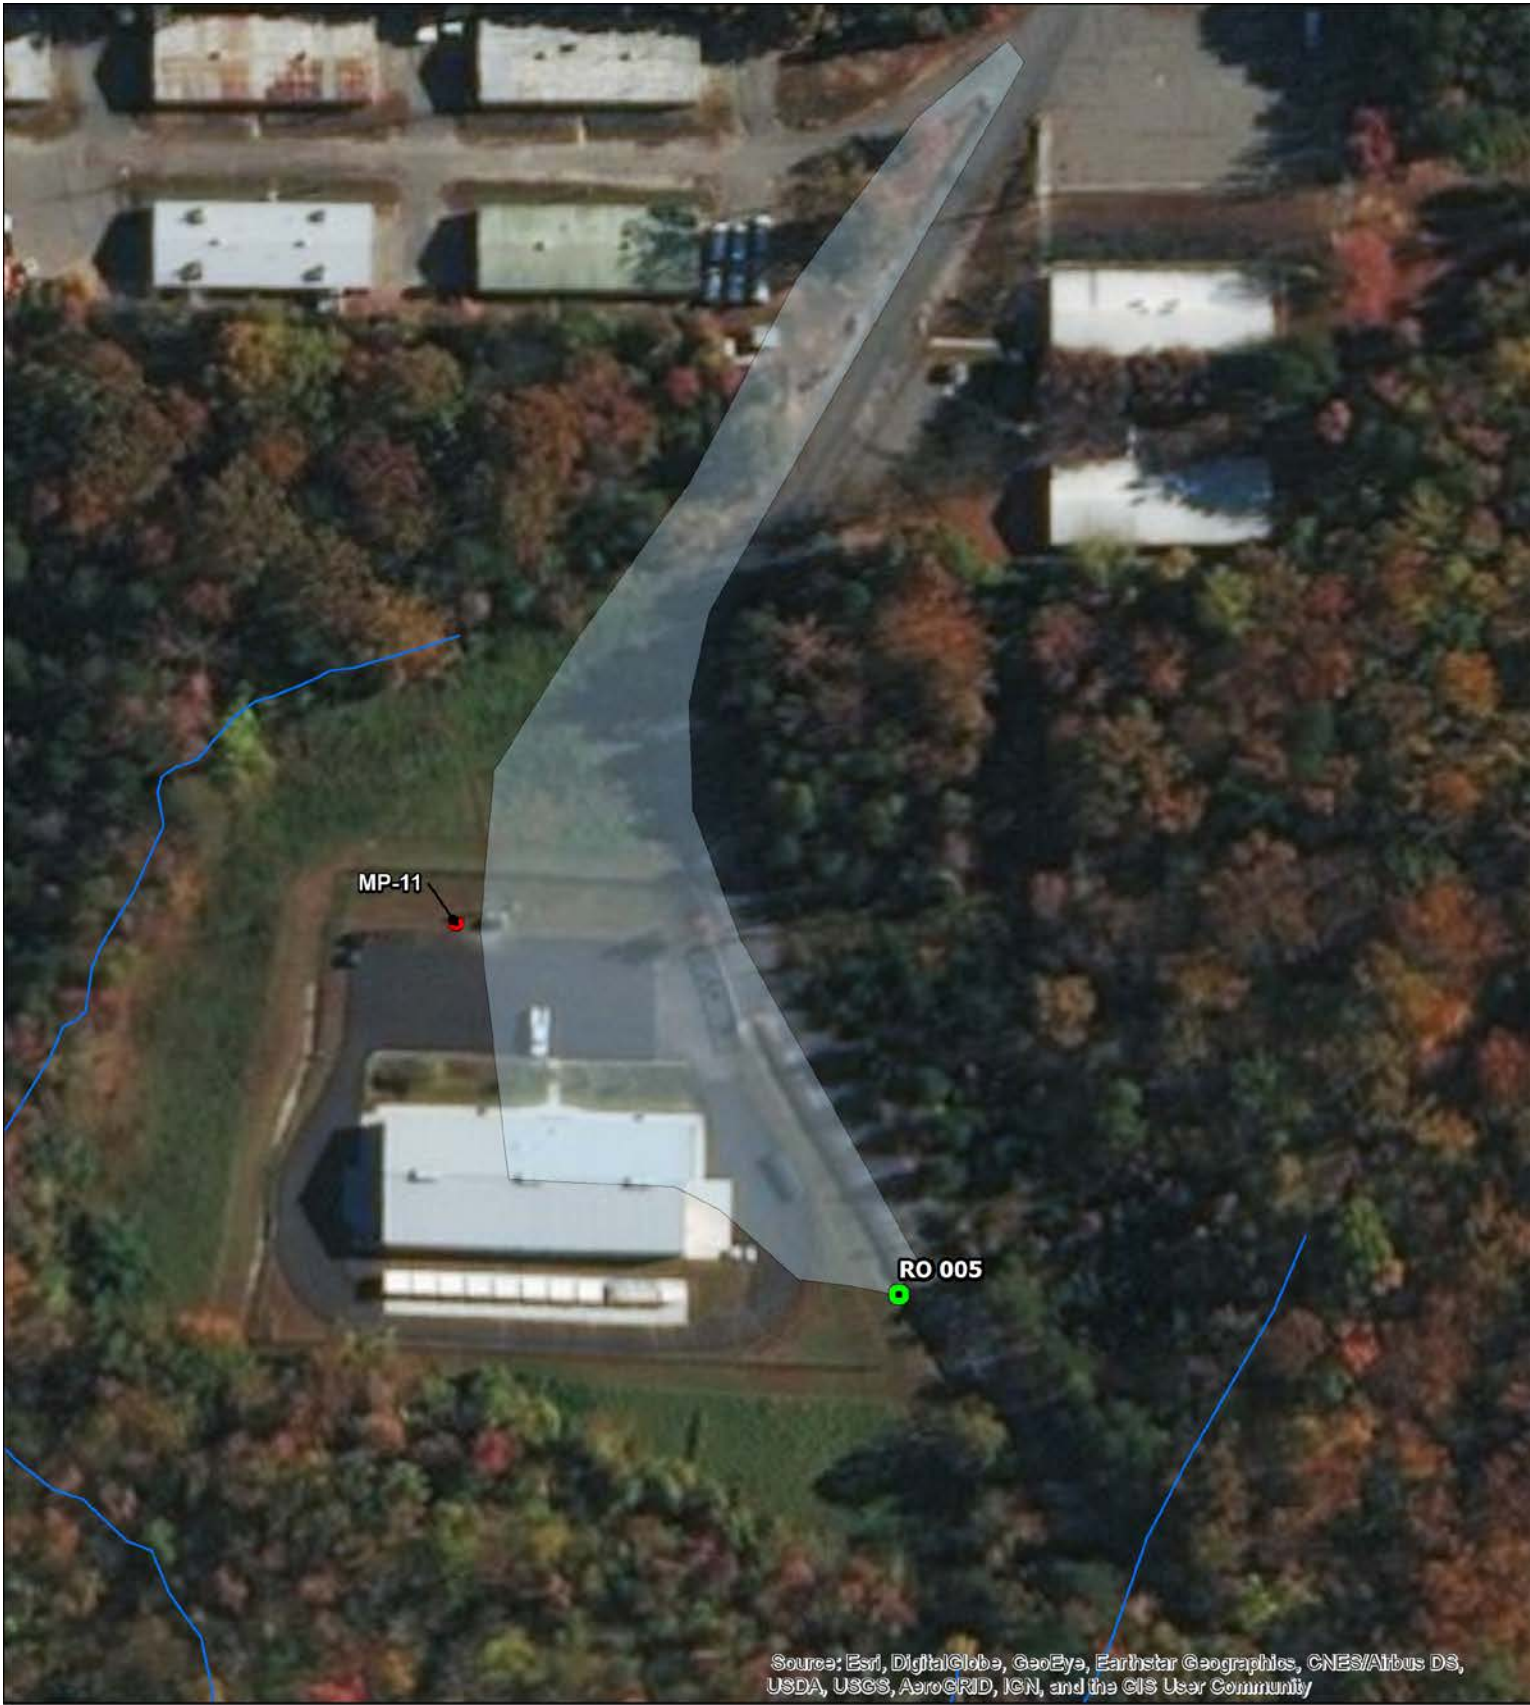
As shown on the drainage map for RO-003, Nine (9) SWMUs are present within the drainage area of this outfall, all nine SWMUs are closed as either AC-UU/UE or NFA-UU/UE. Environmental investigations to include soil sampling were conducted at eight SWMUs and groundwater sampling was conducted at seven of these SWMUs. Six (6) of these SWMUs were within the former Fire Control Training Area where training activities were discontinued in May 1990. The remaining SWMU was administratively closed because reviews of historical records indicated that there were no documented releases or spills of hazardous materials to the environment in relation to them. These nine SWMUs are discussed below.

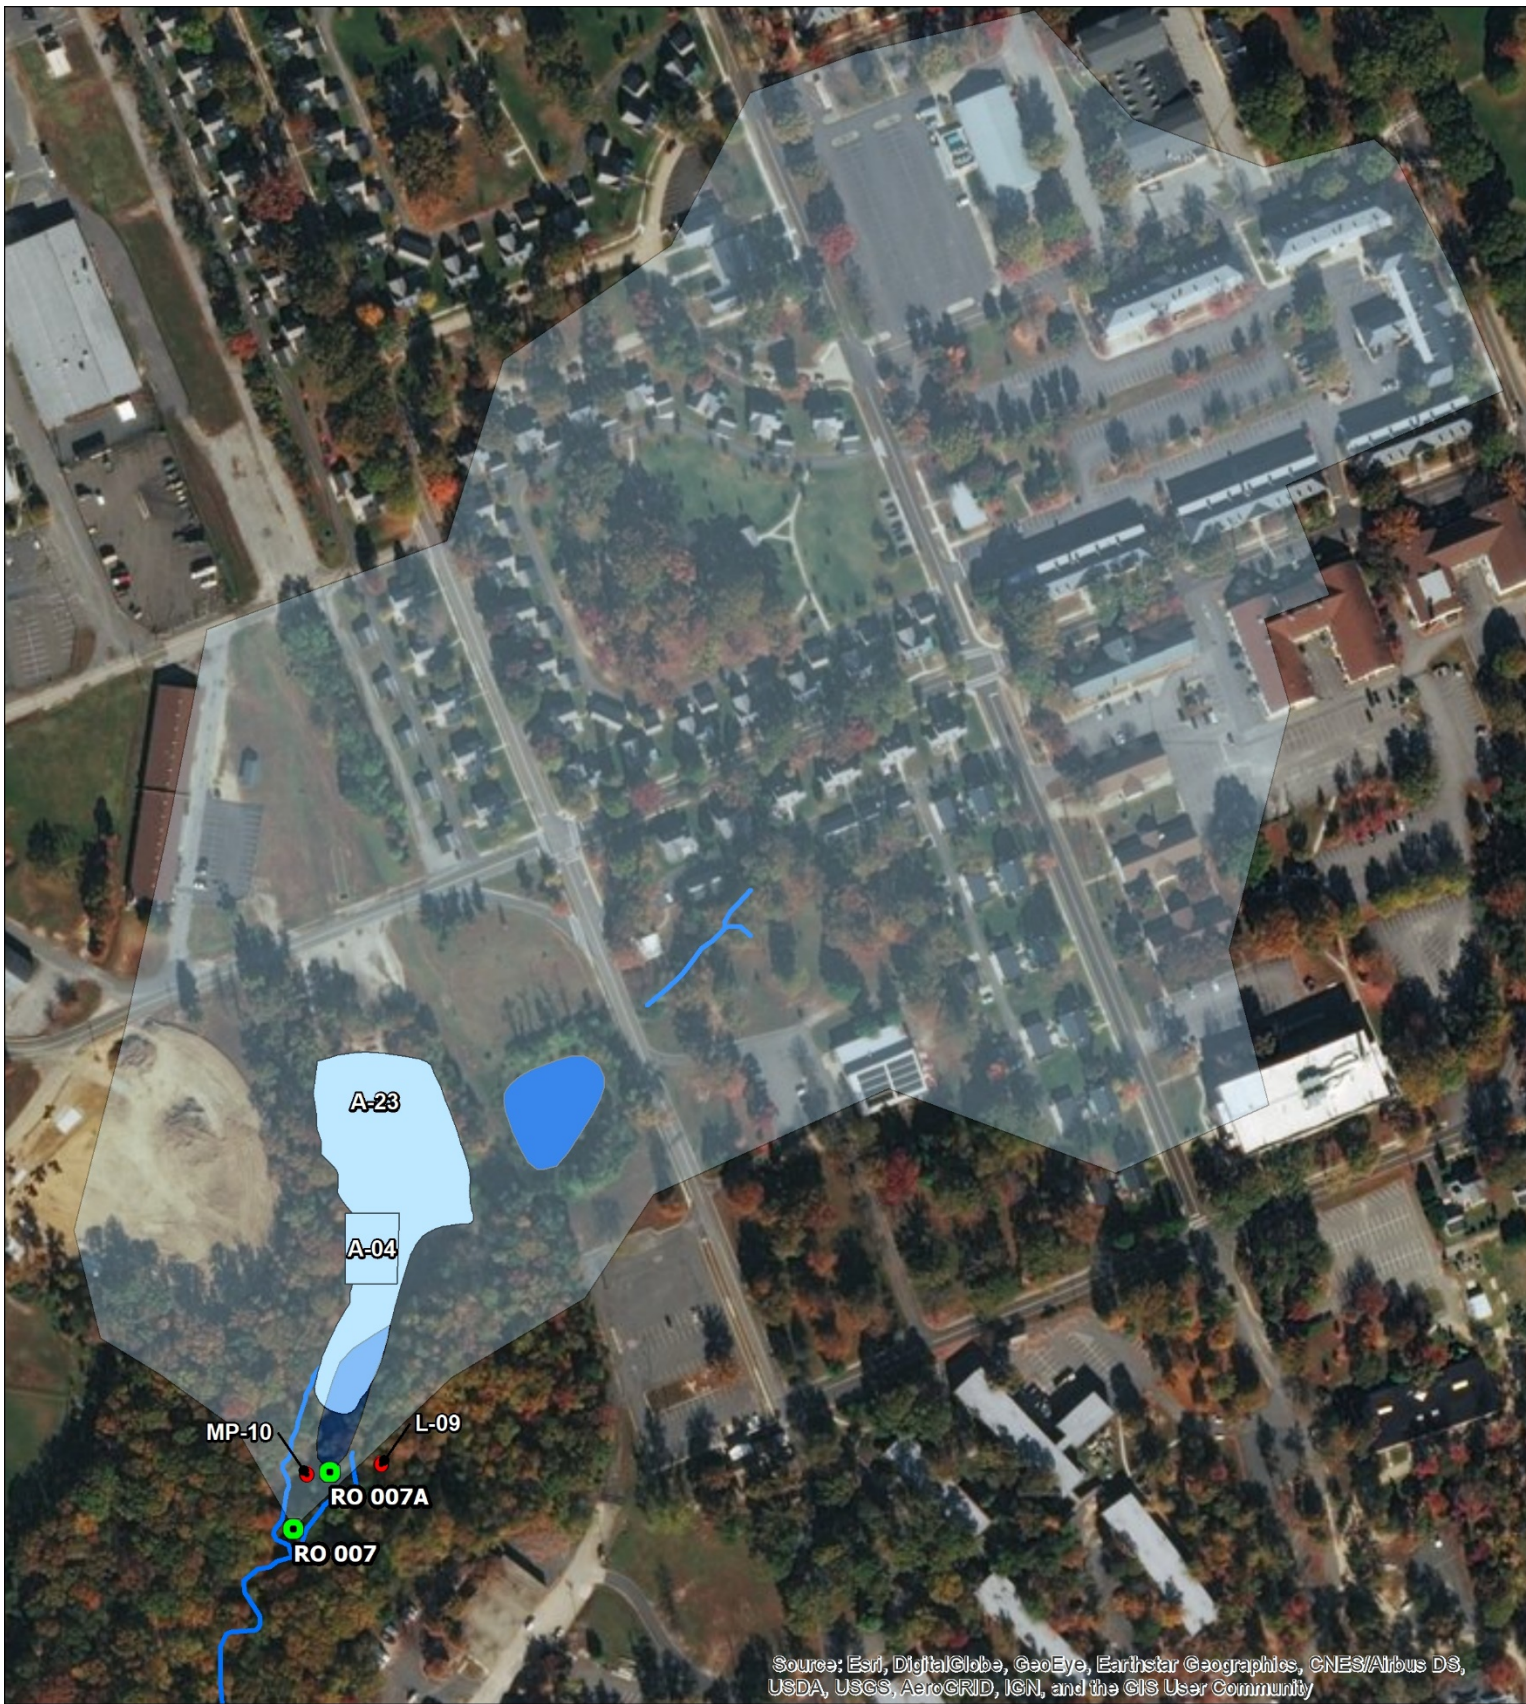
As shown on the drainage map for RO-006, no SWMUs are present in this area.
